Kaizen for Footprint Reduction and Process Flow Improvement at Great Plains Industries

Joyce Chiam Ziyi and Anh Kieu

Department of Industrial, Systems and Manufacturing Engineering
Wichita State University
1845 Fairmount St,
Wichita, KS 67260, USA

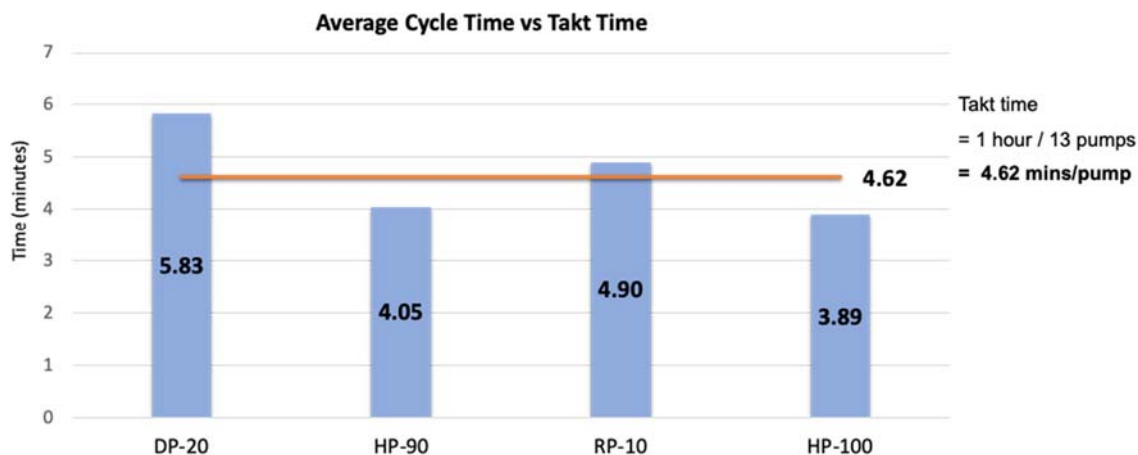
Figure 1. Time Study Analysis

The time study data also provided a good analysis on the current state. As shown in Figure 1, it can be observed that the cycle time to produce DP-20 and RP-10 was larger than the expected takt time. The takt time in this case was quantified based on the demand of 13 pumps an hour, where $\frac{60 \text{ minutes}}{13 \text{ pumps}} = 4.62$ minutes, which was denoted as the orange line in the chart. By using the takt time as a baseline, the current performance can be easily analyzed and compared to after the new layout is implemented. Therefore, another goal of the new layout was to bring the numbers down so that customer's demand can be met, while optimizing floorspace within the facility. Interviews with the operators, shop floor supervisor and the on-site Lean Team were also logged for a more detailed inside view. From the staff, the team gathered that there were certain specific guidelines regarding workspace clearance that needed to be followed, such as a three-foot distance for operators to walk within a workstation, an eight-foot distance for both transportation and operators to access inventory and materials, and at least one safety exit.

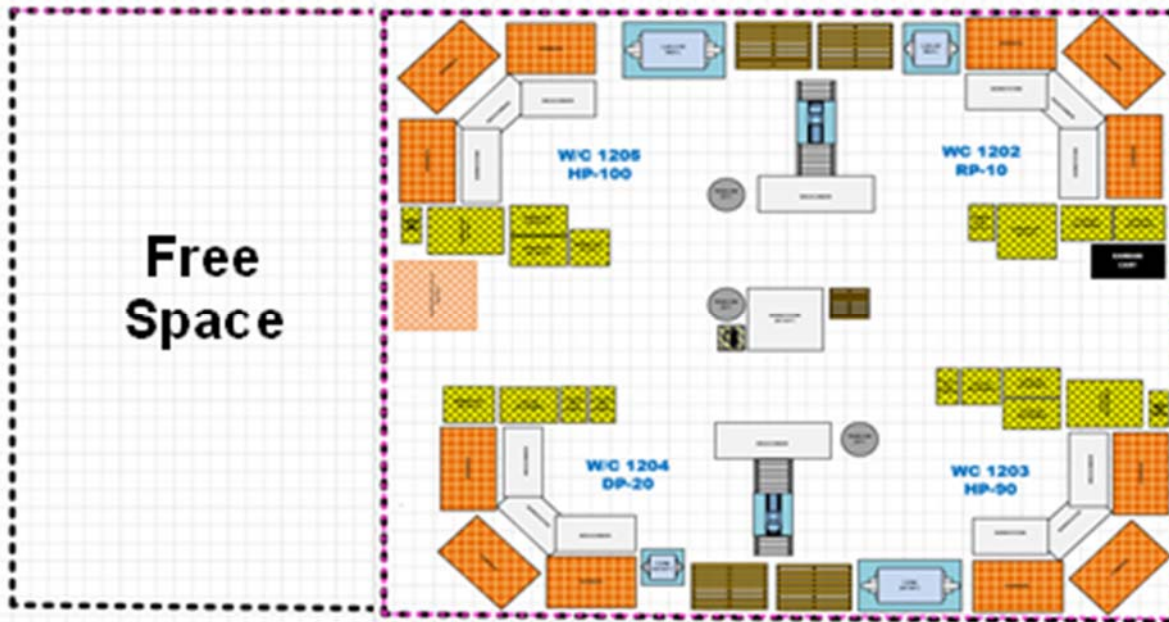
Figure 3. Integration of all three alternatives in overall proposed layout.

The first proposed solution was to have materials replenished from the outside of the work cells. In the current layout at GPI, there was approximately 15x8 feet of wasted space within the work area. This is to accommodate for water striders on work assist vehicles (WAV) to enter the replenishment area. A water strider (also known as a water spider or “mizushumashi” in Lean terms) is a person who carries out the replenishment of materials that the primary operator needs on the assembly line. This allows the operator to stay focused on the job and not worry about acquiring materials themselves.

The second solution approach was to implement the well-known Lean concept of U-shaped cells. This approach is known as “shojinka”, meaning to optimize the work center layout that can support a varying number of operators performing tasks in the layout. One of the known advantages of U-shaped cells is the flexibility for line balancing. Despite the fluctuating demand of hand pumps at GPI, line balancing was implemented, and with this suggestive configuration, operators can move from one station to the other with minimal effort at a shorter distance. It was understood that the work contents within a U-shaped cell was supposed to flow from left to right, while the suggested layout had two of the assembly lines flowing right to left (Rekiek, 2002).

The third solution approach was to change the location of hose assembly cell to feed all four workstations at minimal distance and time. With the hose assembly workstation located in the middle, operators would not need to travel long distance to replenish hoses within the work cells. This would greatly reduce the waste of motion and transportation, which were previously mentioned as part of the Eight Wastes of Lean.

According to the simulated layout, there was a potential reduction of 15 feet in length and 32.5 feet in width of space, which was a substantial contribution to the shop floor. That totaled up to approximately 400 square feet in footprint reduction. This equated to about a savings of \$9,000 per year in rent per square foot and electricity usage. Besides that, this extra space also allowed GPI to bring in new product assembly to the shopfloor for a more significant profit generation.

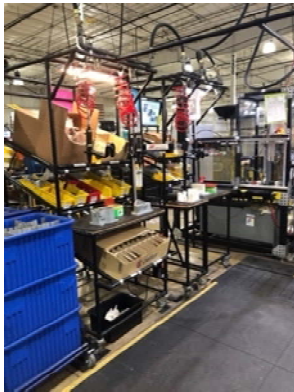
Figure 4. Customized lean tables

Apart from that, the team discovered that the other workstations on the shop floor utilize customized Lean tables as shown in Figure 4. This would result in less footprint, travelling distance, and motion for operators when assembling the hand pumps. It had also been proven around the shop floor that these customizable lean tables can alleviate many ergonomic risks. The flexibility of customizing the worktable made it easier to accommodate for different processes and work contents.

Team members then calibrated more measurements of the equipment, work area, and Kanban bins (Apreutesei, 2010) and suggested optimal dimensions for the new worktable. The team also worked very closely with the Lean Team on obtaining a scaled model of the layout and generating the cost of implementation. After consulting the Lean team at GPI, a cost of implementation was generated. This gave a promising idea of how much GPI would need to spend if the Kaizen event was deemed worthy and beneficial to the company. The majority of costs listed were for the construction of worktables but labor cost for the implementation was considered as well. The team provided a minimum and maximum value of cost to the company sponsors. The minimum cost was the least amount of budget that GPI would need to allocate to this project if they did decide to proceed with the Kaizen event proposed. The maximum cost included unforeseen issues, such as a delay in material, additional material, labor and equipment or any unpredictable problems. With this, the team proposed a cost ranging from \$7,890 to \$9,700 to Great Plains Industries for the entire Kaizen Event. The cost breakdown is shown in Table 7. That being said, the team estimated a yearly savings of \$9,000 when the solution proposals were implemented.

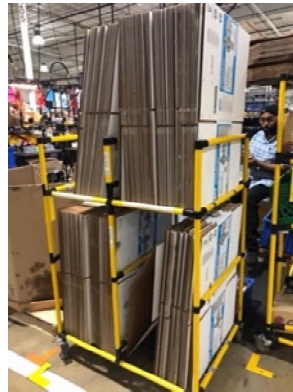
Figure 5. Cardboard carts

Moreover, the current placement of packaging cardboard boxes took up a significant amount of space in the work cells. With the unfolded cardboards placed flat on the ground, approximately twelve square feet were reserved for the boxes within each hand pump assembly line. That added up to a total of forty-eight square feet solely for storing packaging boxes on the floor. Therefore, the team developed a suggestion that was late implemented within GPI – Lean pipe cardboard racks. Cardboards could then be stored vertically on the racks, which would utilize a considerably smaller amount of space in the workstation. In addition, the operators would not need to reach to the ground when cardboards were being used up; hence, the ergonomic risks in this case were mitigated.

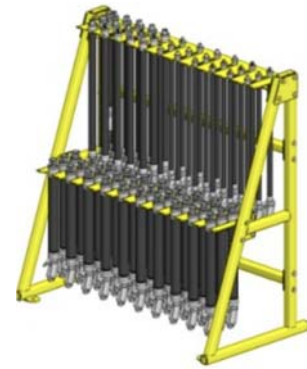
Figure 6. Hose rack

The final suggestion was to utilize mobile racks to store hoses. Currently, GPI stored the hoses in boxes which can be hard to reach the bottom for operators. The hoses also dominated a lot of space within the workstation when placed flat on the ground. With the hose racks, operators could easily reach for the hose and pull it downwards to take it off the rack for packaging purposes. These racks also had caster wheels installed so operators can move them around as needed to cater to the assembly line and overall demand.

In regard to the suggestion about using racks to store hoses, one employee from GPI pointed out that it may cause more inconvenience than good. This was due to the fluctuating demand of each hand pump as well as the different configuration and types of hoses needed. There may be more wasted space with all the hose racks laying around in the work cell that was not being used by the operators. The team agreed with the feedback and decided to recall the suggestion. The current hose system worked well for the company, and the team did not want to affect the current state negatively.
